Smoke and Dye-Water Observation Summary

Western Run Pilot Project - Baltimore Maryland

Dye Test 94

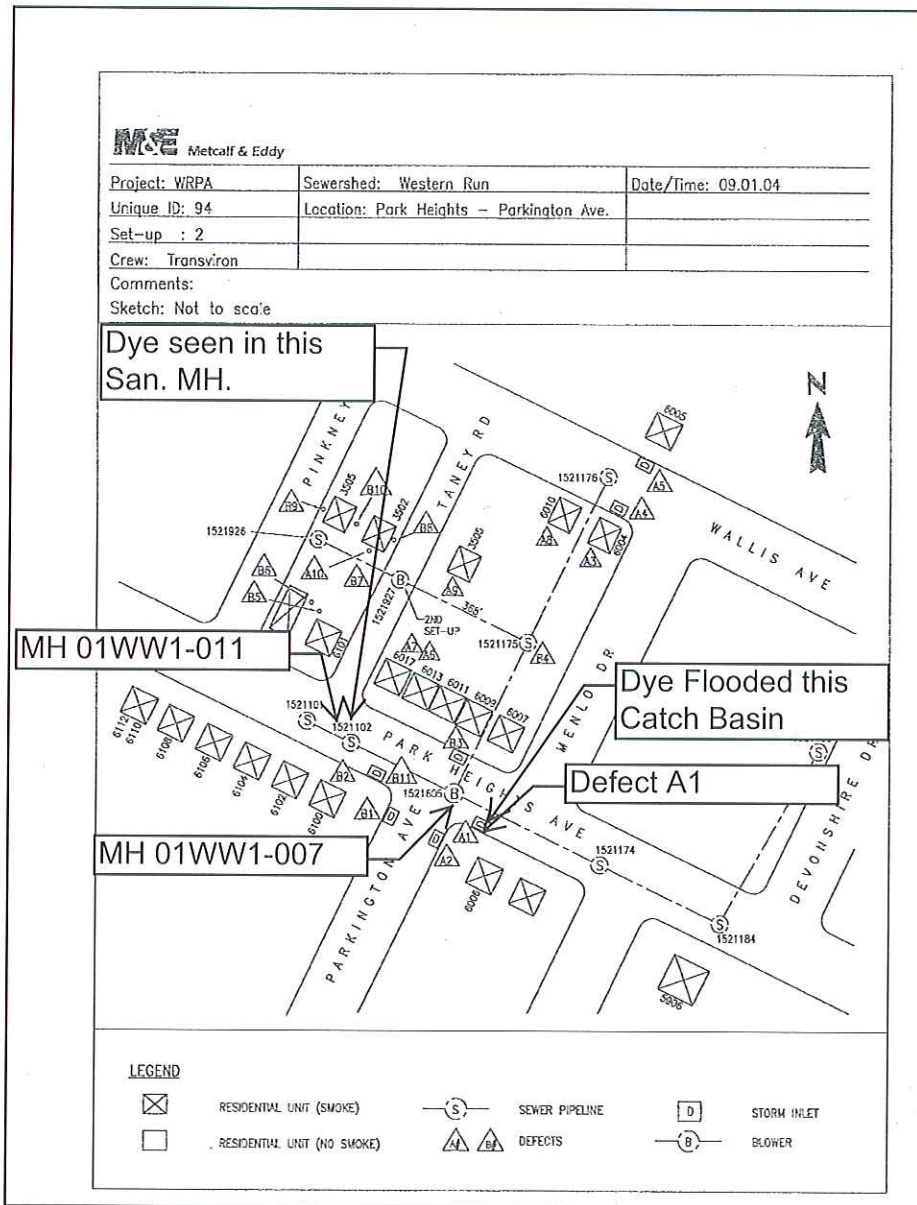
Sketch No: 94

Dye seen in this
San. MH in the
Drop Conn.

Dye Flooded this Catch
Basin

RESIDUAL CODES	SOURCE - WHERE CODES			
1. POSITIVE	1. MAIN SEWER	5. DOWN SPOUT	9. STAIRWELL DRAI	13. STORM DRAIN
2. NEGATIVE	2. SERVICE LINE	6. DWNSTPT CONN.	10. FOUNDATION DRAIN	14. CATCH BASIN
3. CANNOT TEST	3. TRANSITION JOIN	7. AREA DRAIN	11. BUILDING INTERIOR	15. STORM MH
	4. CLEAN OUT	8. DRIVEWAY DRAIN	12. MH FRAME/SEAL	16. STORM DITCH
Additional Comments: DYE LEAKS THROUGH JOINTS OF THE DROP CONN. NOT THE LINE ITSELF. FROM SAN M.H. 1521102

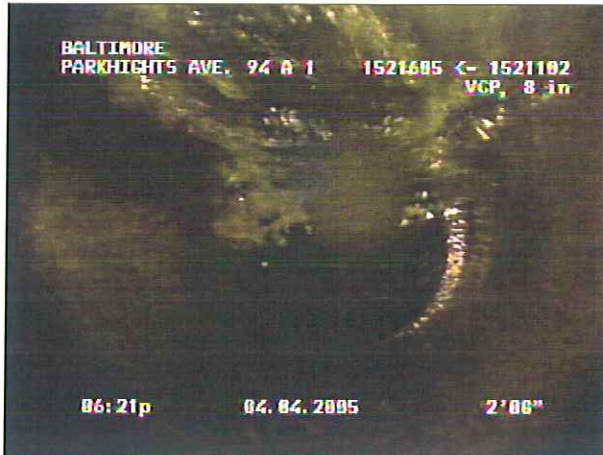
IMAGE: 15a, TAPE #: JAM 2, 00:07:27
2FT, DROP FROM LINE OF 1521102

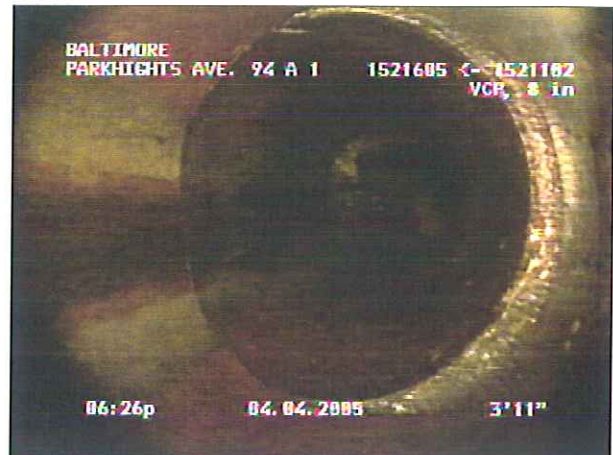
IMAGE: 16a, TAPE #: JAM 2, 00:10:07
3.92FT, Infiltration Running at joint at 07 o'clock, DOWN THE DROP
